DEPARTMENT OF TRANSPORTATION**DIVISION OF ENGINEERING SERVICES**

Contract #: 04-0120F4Cty: SF/ALA Rte: 80 PM: 13.2/13.9File #: 69.28**WELDING INSPECTION REPORT****Resident Engineer:** Pursell, Gary**Address:** 333 Burma Road**City:** Oakland, CA 94607**Report No:** WIR-007527**Date Inspected:** 17-Jun-2009**Project Name:** SAS Superstructure**OSM Arrival Time:** 700**Prime Contractor:** American Bridge/Fluor Enterprises, a JV**OSM Departure Time:** 1900**Contractor:** Zhenhua Port Machinery Company, Ltd (ZPMC), Changxing Island **Location:** Shanghai, China**CWI Name:** Xu Le Feng, Liu Yang**CWI Present:** Yes No**Inspected CWI report:** Yes No N/A**Rod Oven in Use:** Yes No N/A**Electrode to specification:** Yes No N/A**Weld Procedures Followed:** Yes No N/A**Qualified Welders:** Yes No N/A**Verified Joint Fit-up:** Yes No N/A**Approved Drawings:** Yes No N/A**Approved WPS:** Yes No N/A**Delayed / Cancelled:** Yes No N/A**Bridge No:** 34-0006**Component:** TOWER**Summary of Items Observed:**

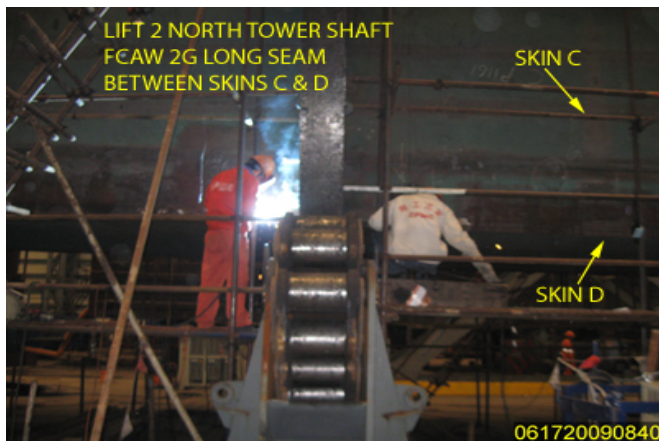
The QA Inspector randomly observed ZPMC welders ID 202821 and ID 066155, utilizing the FCAW Process in the 2G (Horizontal Groove) Position with ZPMC WPS WPS-B-T-2232-TC-U2-F to weld the long seam on either side of the upper jig ring on Lift 2 West between Skin Plates C and D. The QA Inspector randomly observed ZPMC QC monitoring weld parameters. Weld parameters appeared to comply with contract requirements. The attached photograph provides additional detail.

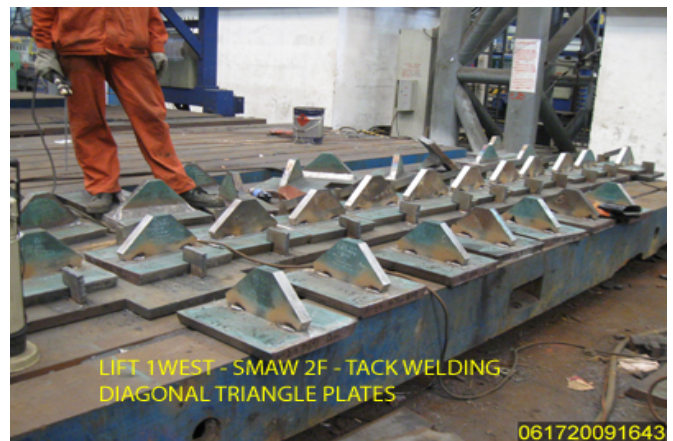
The QA Inspector randomly observed ZPMC welder Li Wei Ya ID 202821 and ID 066155, utilizing the Shielded Metal Arc Welding (SMAW) Process in the 2F (Horizontal Fillet) Position with ZPMC WPS WPS-B-P-2112 to tack weld the triangle plates to the diagonal plates for Lift 1 West Tower Shaft. The QA Inspector randomly observed ZPMC QC monitoring weld parameters. Weld parameters appeared to comply with contract requirements. The attached photograph provides additional detail.
